MARINE SURVEYOR

REPORT OF A CONDITION SURVEY CARRIED OUT ON THE VESSEL:

“ [REDACTED] ”

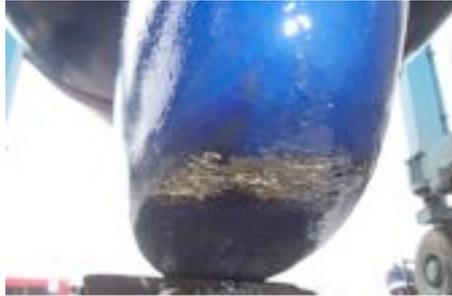
The fore foot and flat underside of the keel (shown) was examined with the boat in slings and no signs of damage or abrasion seen. The gap in the antifouling is presumably where the boat was previously chocked.

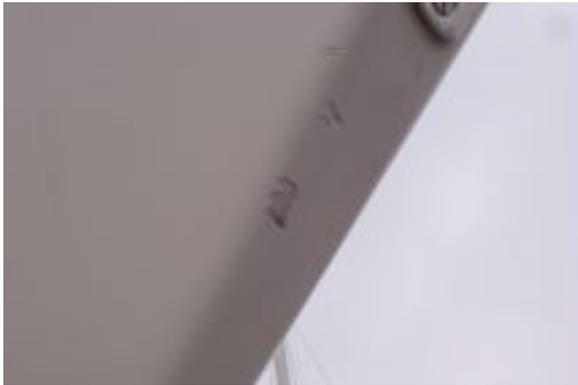
Two minor imperfections were found; there are small resin chips at the stem (see upper photo), the lower of which is through to the underlying laminate. **This should filled (B)** and will take about 1-2 hours. Charges are about £40 per hour for Brighton based GRP repairers. Any loose material should be ground out and the area made good with a white gel coat paste, secured with plastic tape whilst it sets.

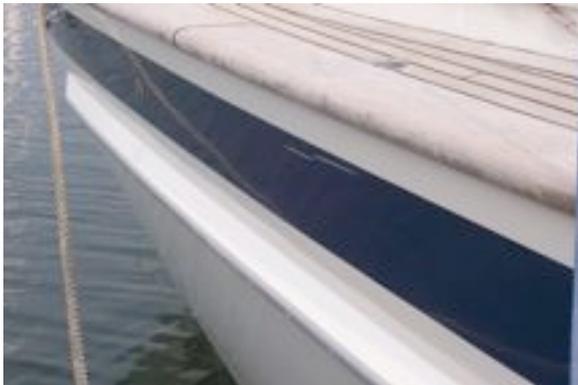
On the port side, 4m forward of the stern, the blue sheer line is scratched (shown) and should be repaired with enamel.

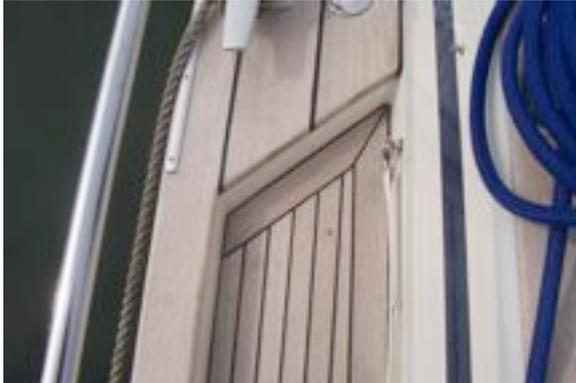
A further minor split was noted around the forward edge of the anchor locker hatch. **This should be re-glued using 'Sikaflex 290' (B).** No other signs of damage or loss of adhesion was found to the teak planking or caulking.

It is important that the watertight integrity of the teak deck is maintained. Any splits or lifting of the planks or caulking, or loss of screw bungs should be addressed immediately. Whilst there are no apparent problems at present, if water does seep into the underlying balsa core via the planking screws, this will lead to expensive repairs. It would be useful to carry a small tube of 'Sikaflex 290' onboard to seal any minor splits. 'Balcotan' one part wood glue is suitable for re-securing any lost screw bungs. The

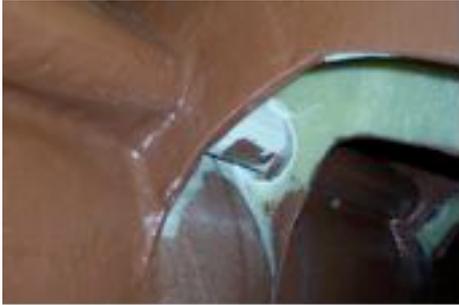
The hull is stiffened by an internal moulding, a series of glassed in plywood bulkheads and webs, and by longitudinal, hollow bearers either side of the keel sump (the photo shows these bearers and the floor webs in the saloon bilge). Where accessible, all were seen to be well made, heavily over laminated and secure. The teak veneer has been removed where plywood bulkheads are laminated into the hull. The longitudinal bearers also act as pipe and cable conduits. The hull

Some minor cracking was noted in the resin flow coat along the edge of the forward bulkhead between the anchor locker and the forecabin. The bulkhead was hammer sounded and weight loaded and no movement found.

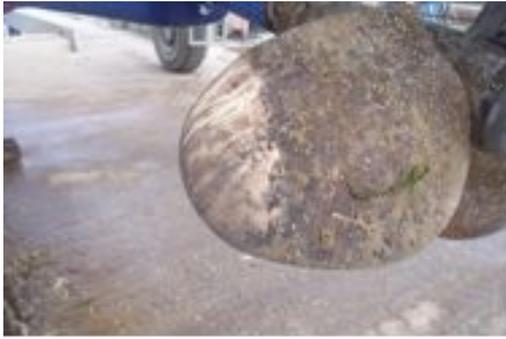
The vessel has a three blade 'Maxprop' self feathering propeller. This was found to operate smoothly and is secure on its shaft. The blades were hammer sounded and scraped and no signs of de-zincification found.

Some vertical play was found on the cutlass bearing which may be significant given that invoices were seen for the entire stern bearing replacement last March and again for the cutlass bearing separately in May (when oil was reported leaking from the shaft). Without information on usage, it is difficult to speculate whether there may be a problem caused by misalignment. If rapid wear is noted by the end of the coming season, it would be advisable to **check the alignment of the external shaft bearing** (i.e to make sure it was not bolted onto the hull slightly out of line with the shaft such that it causes rapid wear of the cutlass bearing) (B).

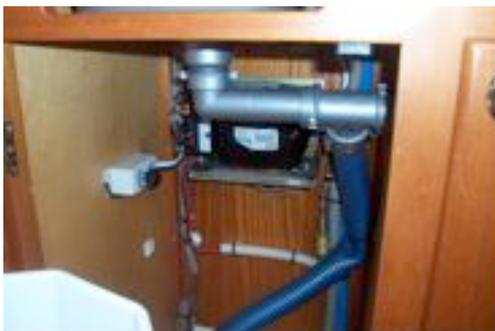
All through hull skin fittings were closely examined for security. Bronze fittings were lightly hammer sounded and their valves checked for smooth operation. Hoses were tested for security and cable clips inspected.

From forward, there is an echo sounder transducer and blanked holder for a paddlewheel log impeller. Both are secure and accessed under the forecabin sole.

On the starboard side aft, there are two 15mm through hull fittings serving the sink outlet and sea toilet inlet, and a 40mm through hull sea toilet outlet. All are in good condition, have dezincification resistant (DZR) ball valves and reinforced hose which is securely clipped. Access is from the locker under the aft toilet cabin sink.

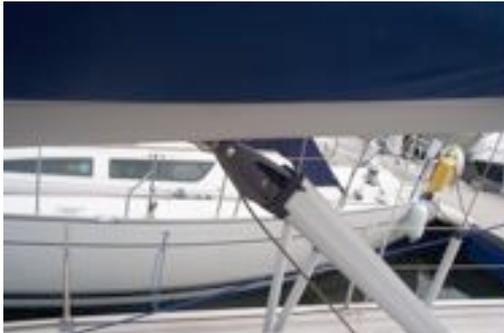
The kicking strap is a 'Seldon Rod Kicker'. It is secure at the base but the boom fitting has pulled out of the metal section and cracked as shown. **The entire unit should be replaced (A)**. The manufacturer's recommended price for a new strap is £274 for this type, or £418 for a gas strut model which removes the need for a backstay and allows the boom to be raised in light winds to put more shape into the sail. The unit can be owner fitted. It is secured with

clevis pins top and bottom. SMR rigging in Brighton (01273 668904) can supply.

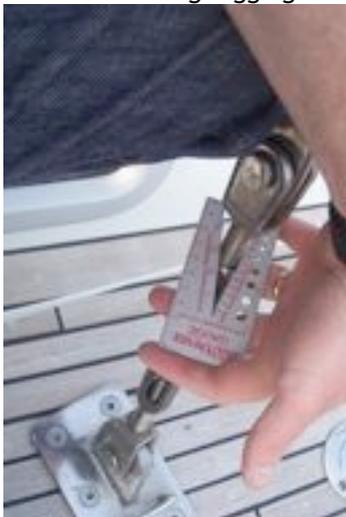
Some of the upper rigging terminals appear to have been wrapped with white electrical tape. This is not good practice because water retained against stainless steel will cause crevice corrosion. Stainless surfaces should be open to air or free flowing water to allow the chromium content to

The lower terminals have aluminium rigging screw covers, all in good condition. All were lifted to inspect the underlying terminals and all were found in good condition with no missing pins or split rings. The photo (previous page) is typical, showing 15mm rigging screw threads, secured with split pins and attached by forks to 10mm stainless welded chain plates.

oxidize and form the 'stainless' surface. **The tape should be removed when the mast is next lowered (B).**

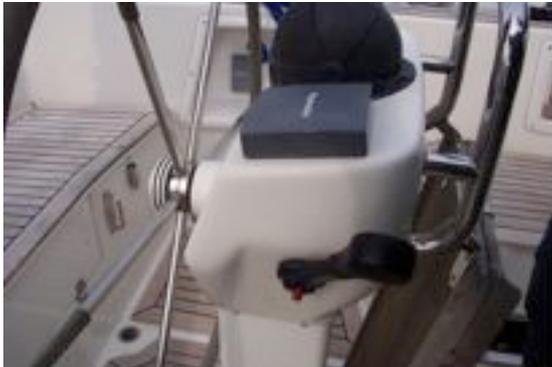
The vessel has a Yanmar 4JH3B engine. This has a standard control panel to starboard of helm. There is no hour counter. There is a single lever control which is securely attached and works smoothly. The neutral détente is about 45° forward of vertical (shown) which is confusing and potentially hazardous if someone unused to the boat brings her alongside. **It should be adjusted so that the lever lies vertical in neutral (B).**

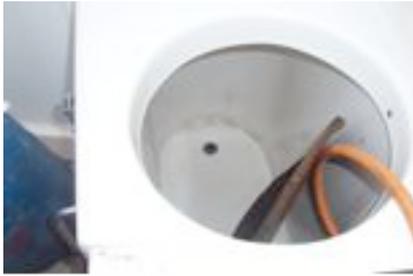
Two 7kg gas bottles are stowed to starboard in the stern locker. The bottom of the gas locker is lined with a rubber backed carpet to prevent rattling and rust stains (shown). However this also blocks the drainage hole of the gas locker and it is recommended a hole is cut in the carpet (A).
